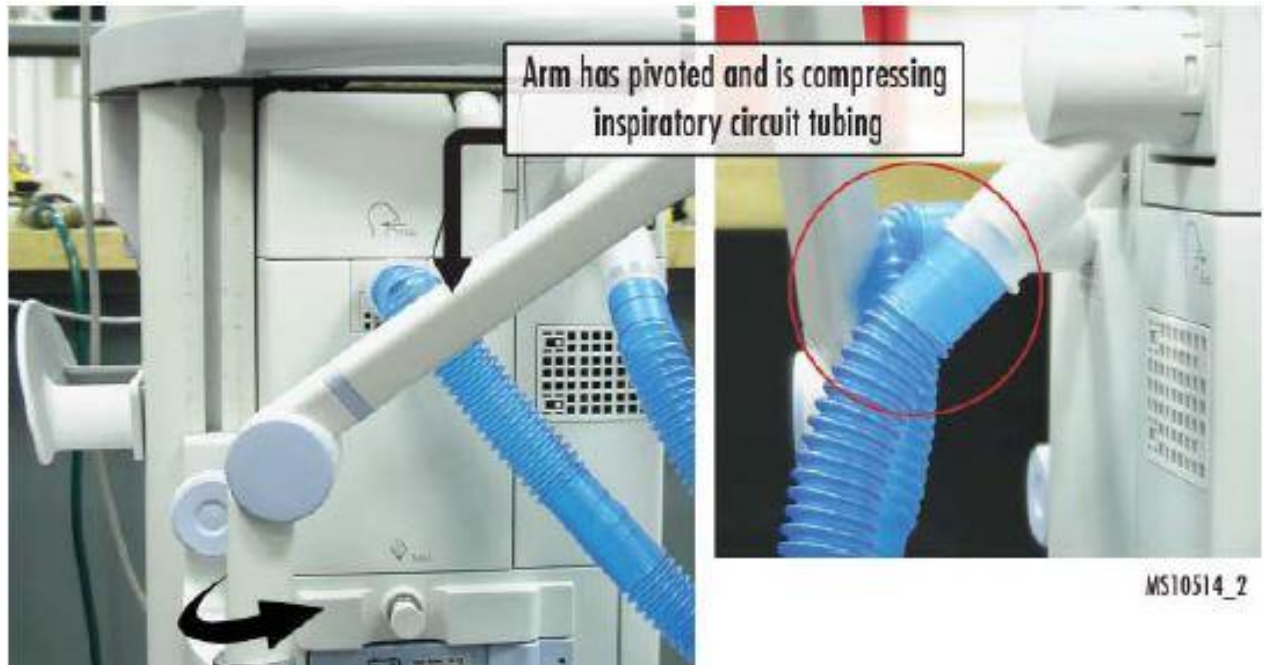
**Figure 2.** The arm has pivoted inward toward the cart and is compressing the circuit's inspiratory limb. This is possible because the articulating joint is below the level of the inspiratory port. If the joint is kept above the level of the port, this problem cannot occur. Another option is to mount the support arm on a different side of the ventilator, but this may not always be feasible.
